MOST PROJECT #2 24 May 1954  
REPORT 516

⑥ Modification and Repair of Surface-Vessel Bathythermograph OC-2B/S.

⑩ R. C. HINCK ENGINEERING DIVISION

U. S. NAVY ELECTRONICS LABORATORY, SAN DIEGO, CALIFORNIA  
A BUREAU OF SHIPS LABORATORY

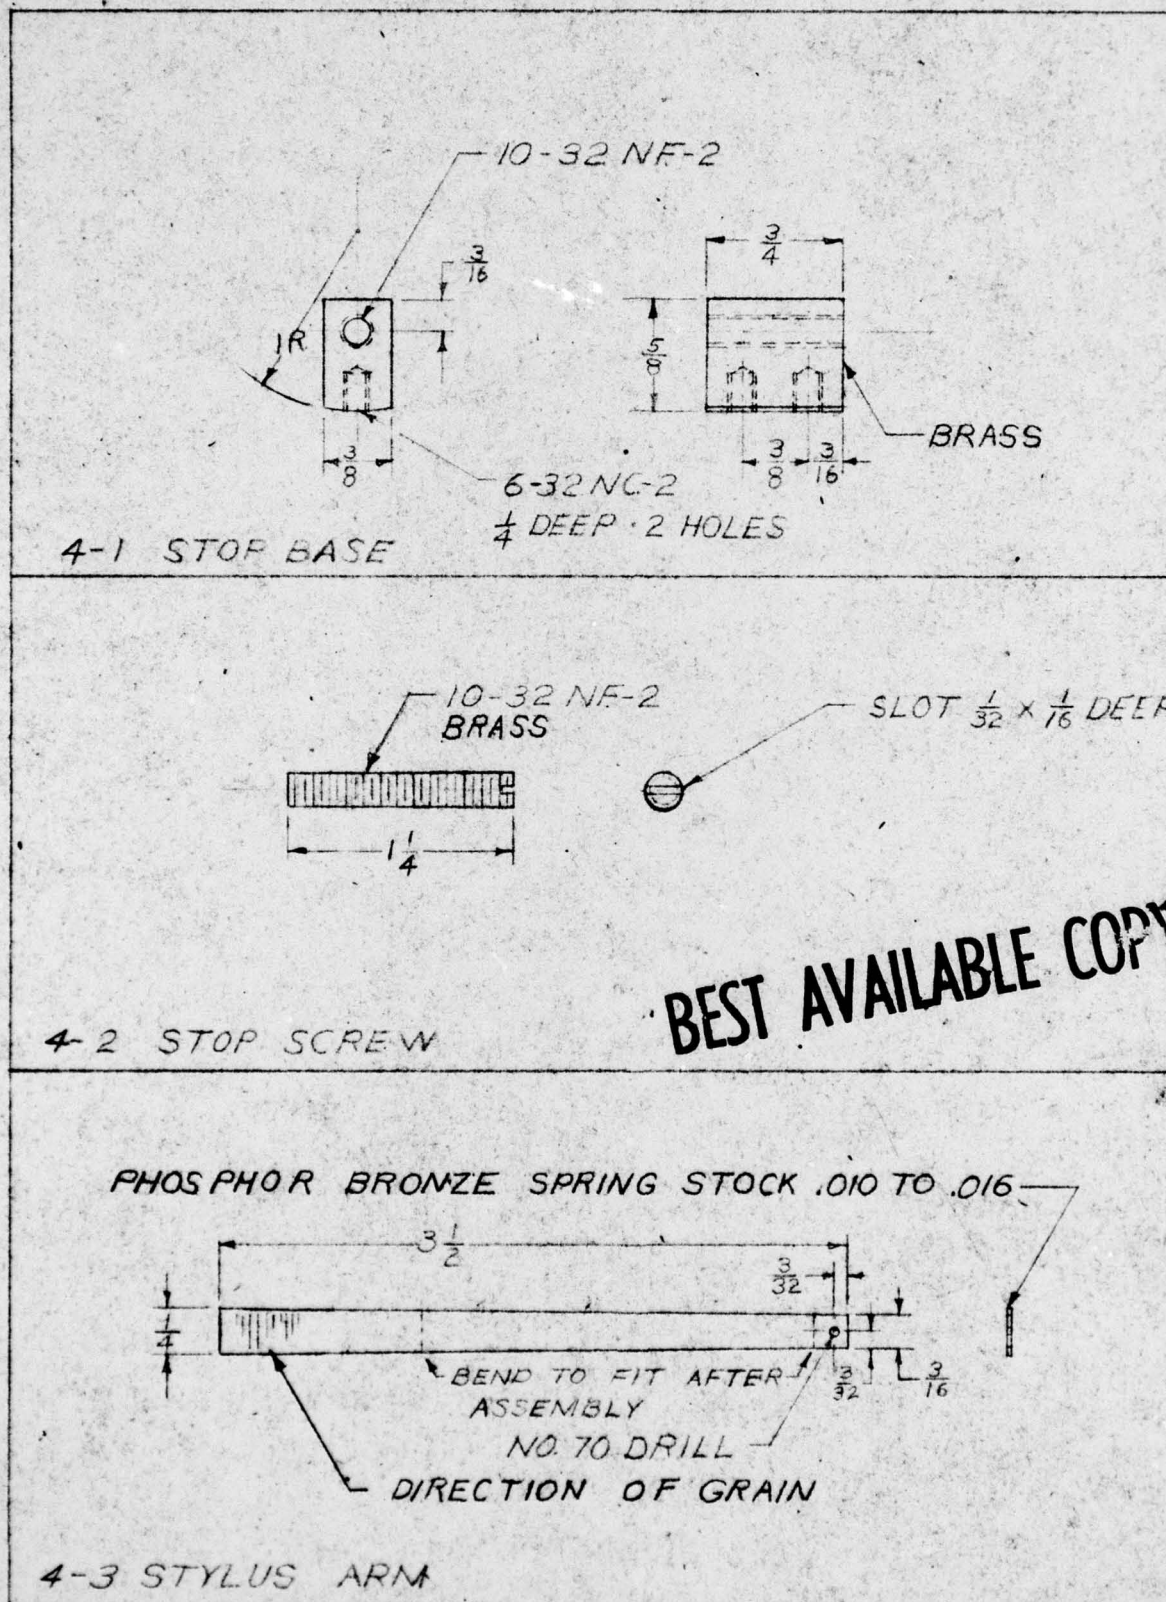
FIGURE 4 STOP AND STYLUS DETAILS FOR QC-2B/S BATHYTHEROGRAPH

1. The screws holding the tail piece and nose piece were loose as a result of either insufficient tightening during assembly or the vibration and shock encountered during transportation.
2. A shock blow along the longitudinal axis of the BT in its shipping case caused the pressure element to elongate and come in contact with the end of the stylus. This caused the stylus arm to be bent such that it would not touch the glass slide.

Note or mark the position of the stylus arm on the temperature element and with a small soldering iron remove the stylus arm. Remove and save the stylus point from the arm. Make from bronze spring sheet stock (0.010 to 0.016 inch thick), a duplicate stylus arm. Cut the new arm lengthwise across the grain of the stock to permit bending. Drill a no. 70 hole in the center of the small end of the arm and solder the stylus point in place (fig. 4). Solder the new stylus arm on the temperature element, holding to the original stylus position as closely as possible. Bend the stylus arm as necessary to insure firm pressure of the point on the glass slide. Reassemble the BT, installing split lock washers on screws of the nose and tail pieces. Stamp the letter "A" following the serial number to indicate first recalibration. Calibrate the BT and make new corresponding viewing grids as per standard calibration procedure.
